# MAJOR REPAIR AND ALTERATION (Airframe, Powerplant, Propeller, or Appliance)

<b>1. Aircraft</b>	Make <p style="text-align: center;">Ryan</p>	Model <p style="text-align: center;">Navion B</p>
	Serial No. <p style="text-align: center;">NAV-4-2313B</p>	Nationality and Registration Mark <p style="text-align: center;">N5413K</p>
<b>2. Owner</b>	Name (As shown on registration certificate) <p style="text-align: center;">Putney, William W III Rodgers, Gail C</p>	Address (As shown on registration certificate) <p style="text-align: center;">5780 Balmoral Drive Oakland, CA 94619</p>

# N5413K Panel

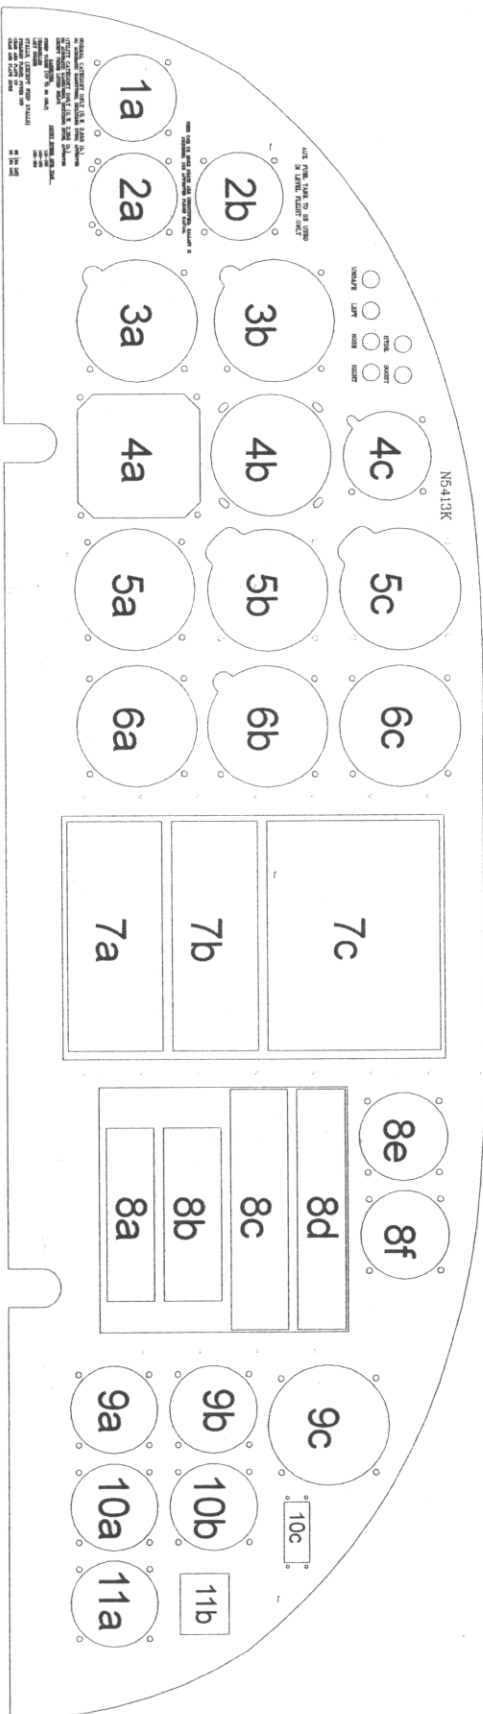
**Description of work:** Installed μ-Encoder instrument at location 5a (see attached N5413K Panel drawing), outside air temperature probe located in the left engine cooling air inlet and remote flux gate compass located at 237.25 from datum point between frames 224 and 349.5. The installation was done in accordance with Rocky Mountain Instrument "μ-Encoder Operation, Programming & Installation Manual". An adapter plate was fabricated to mount the new flux gate compass unit in the location formerly occupied by the old syncro remote compass. No alteration to the aircraft structure was made to accomplish this installation.
